PEPPERELL PAPER CO. DAM

MA 00373

PHASE I INSPECTION REPORT
NATIONAL DAM INSPECTION PROGRAM

Identification No.: MA 00373
Name of Dam: Pepperell Paper Co.
Town: Pepperell, Massachusetts
County and State: Middlesex County, Massachusetts
Stream: Nashua River
Date of Inspection: June 14, 1978

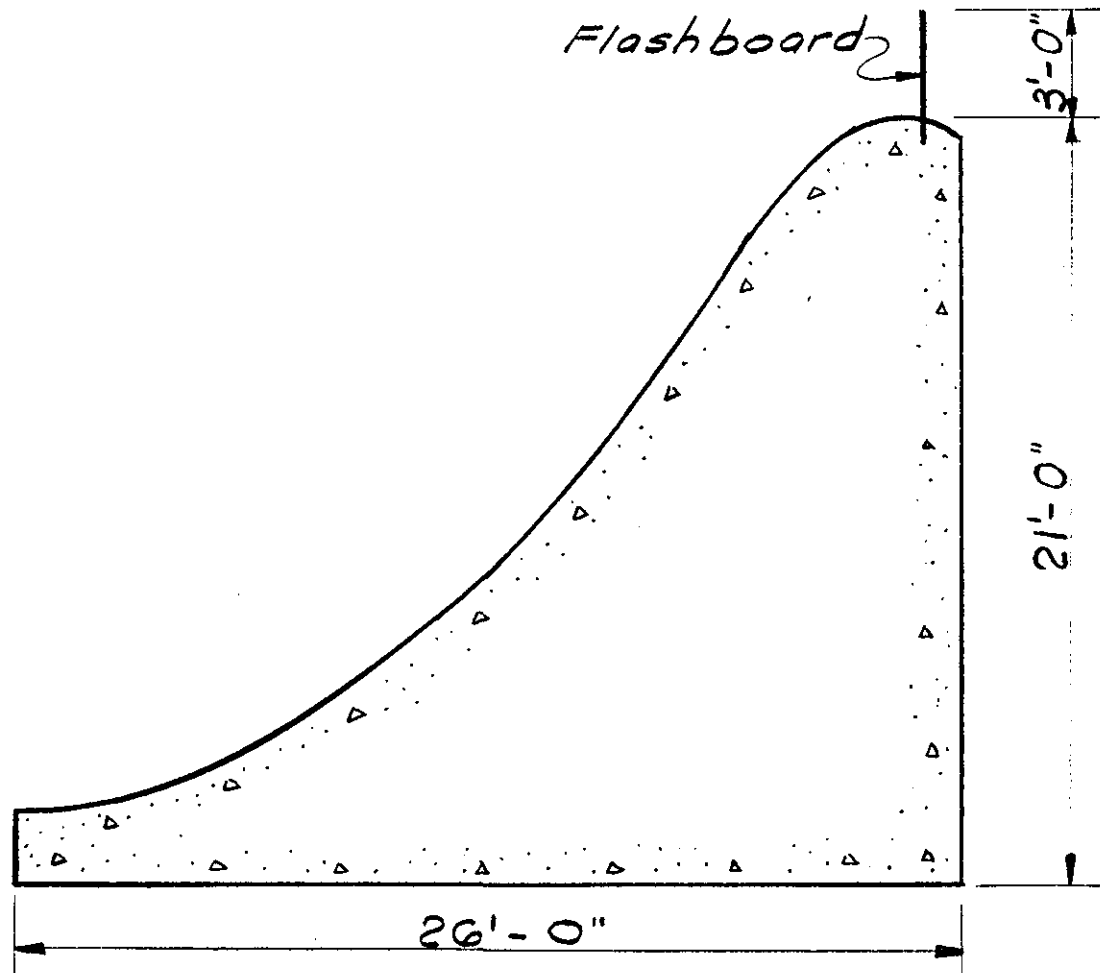
SPILLWAY CROSS SECTION

*This cross section was copied from
a drawing in possession of the
Pepperell Paper Co.*
